HYDEL GEARBOX (TURKEY)

1 TECHNICAL DATA:

2 PREAMBLE / PROBLEM REPORTED

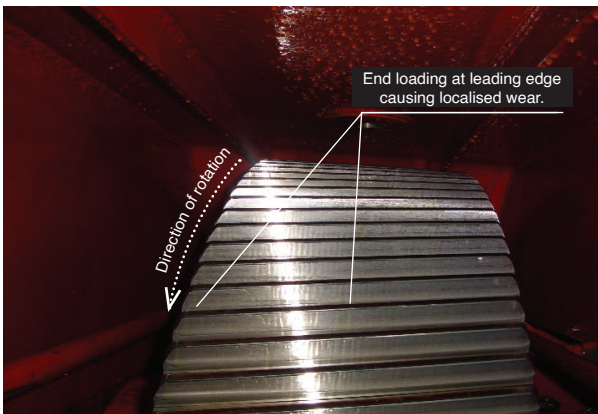
Gear Wheel

The tooth impression in all four gearboxes found identical.

Wear was found on both the pinion and gear wheel towards the turbine side, despite the customer achieving a blue contact of over 80% during gearbox assembly/repair.

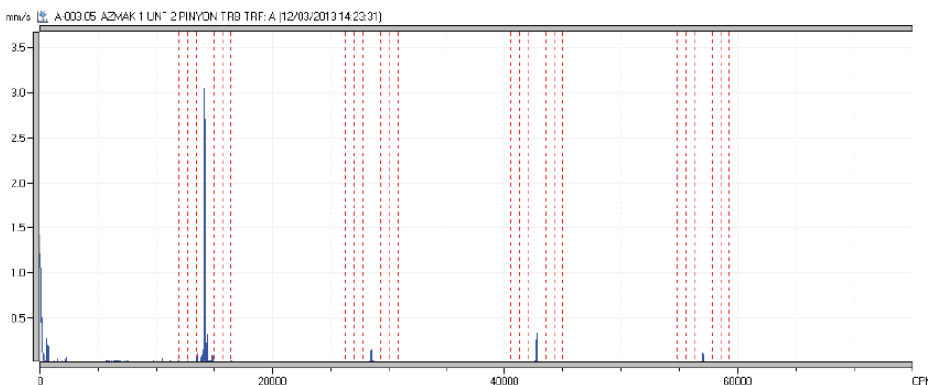
Spectrum analysis of the casing indicated the presence of gear mesh frequency (GMF) with sidebands, along with GMF harmonics at higher loads. Additionally, no GMF harmonics were observed during no-load running. Vibration readings indicated the presence of gear misalignment during load operation.

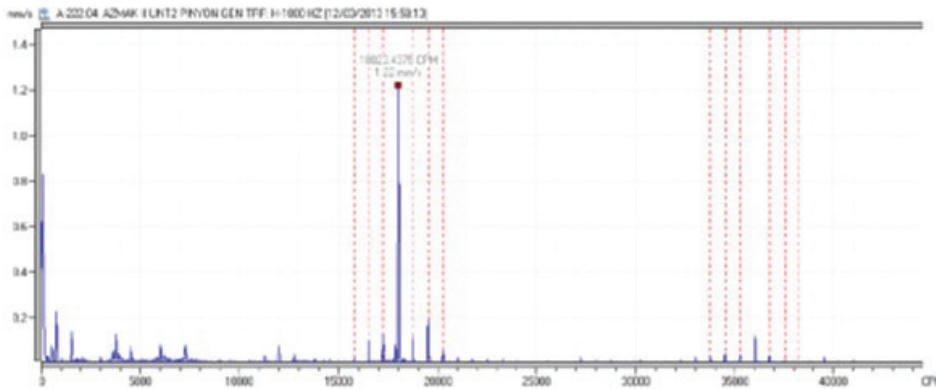
During prolonged operation, significant sidebands were observed around the gear mesh frequency (GMF), primarily due to the initiation of gear wear.

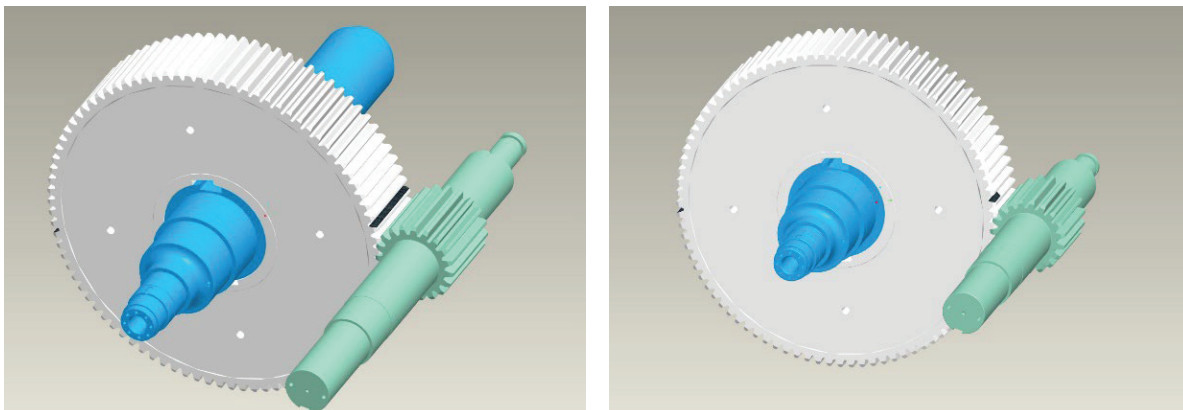
Since all four gearboxes exhibited identical behavior, it was found that the existing configuration of the turbine had axis shift during load operation.

The way forward would be to select a gearbox configuration where tooth contact is not affected under load. A vertical offset gearbox is one such configuration, where any change in the slope of the input shaft axis does not affect the tooth contact pattern. This is because the shaft axis moves parallel to the tooth contact, rather than away from it.
